SERVICE BULLETIN 2008 – 04

TO: ALL CORRECT CRAFT DEALERS
RE: AMP BOARD CONNECTIONS, Select 2009 Boats

October 20, 2008

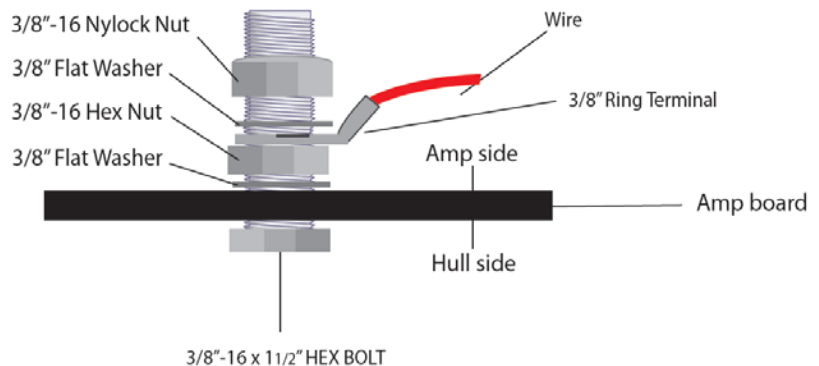
In the boats listed above, if a *factory amp* was installed, it is necessary to upgrade the positive and negative connections on the amp board for the cockpit and tower amp wires. The direct drive and 211 models do not have an amp board and are not included in this bulletin.

INSTRUCTIONS: only the positive stud needs a red boot.

1. Disconnect batteries or turn battery switch to OFF position.
2. On amp board, disconnect all power and ground ring terminals from studs and remove all 1/4" terminal studs.
3. Enlarge stud holes with 3/8" drill bit.
4. Insert 3/8"-16 x 1 1/2" hex bolt from back of amp board and tighten with flat washer and a hex jam nut.
5. Reroute positive and ground wires to **top face** of amp board (it may be necessary to cut electrical tape to free the wires from the harness) and slide a single boot over all wires coming into each positive terminal.
6. Install the remaining fastening hardware on the hex bolt in the order prescribed in the diagram below. Using two 9/16" wrenches, hold the lower jam nut in place while tightening the final nylon lock nut over the flat washer.
7. Slide boot over studs.
