SERVICE BULLETIN 2008 – 05

TO: ALL CORRECT CRAFT DEALERS
RE: FCT2 (Titan) HINGE ASSEMBLY

October 27, 2008

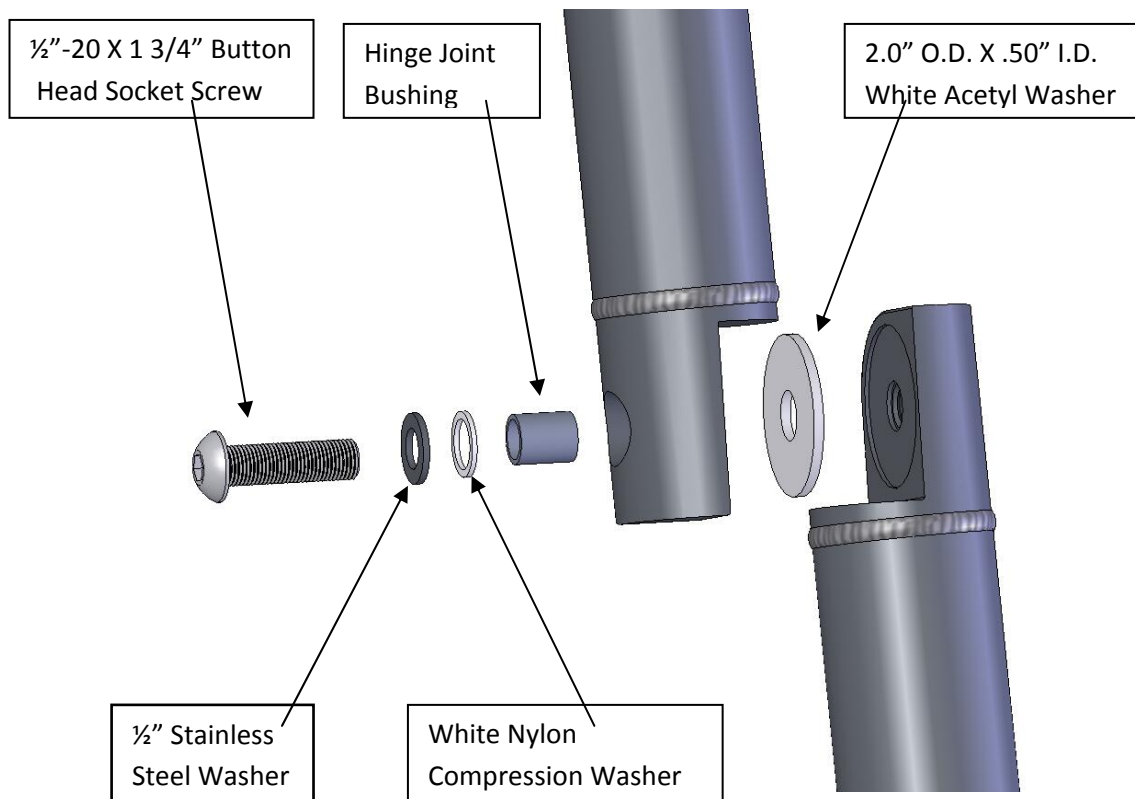
We have heard of a few instances of the FCT2 hinge joint becoming loose. If this issue is brought to your attention:

NOTE: The 1/2" Stainless Steel washer should be assembled to the outside of the White Nylon Compression Washer. This allows the White Nylon Compression Washer to be trapped and compressed into the hinge counter bore. Failure to assemble the Hinge Joints in this way will cause failure of the White Nylon Compression Washer; this may possibly reduce the performance of the Tower shortening the life of the hinge joint.

1. **Confirm the proper placement of the hinge hardware as pictured below.**
2. If the hardware is loose, apply Loctite "Blue" 242 to the socket screw and tighten to 40 foot pounds.
